5KVA-120V maintenance SOP

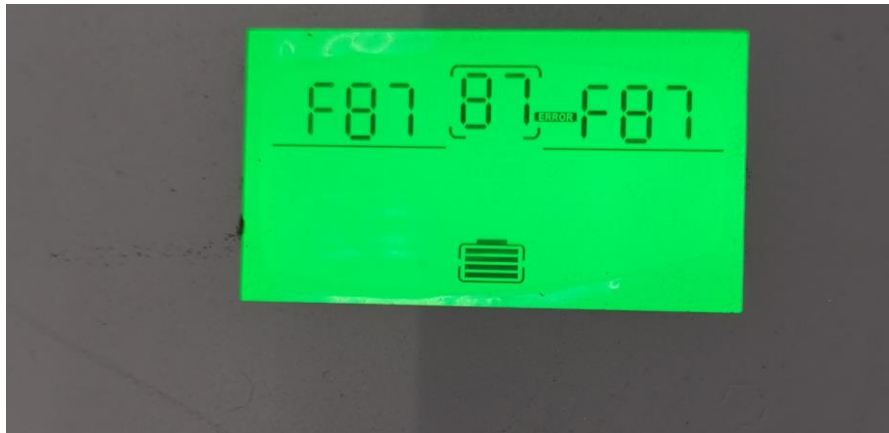
After our lab simulation test, If the short circuit cap is not installed in the control board on the right, will result in **【87】** . Therefore, you can use the steps below to solve fault **【87】** short circuit cap

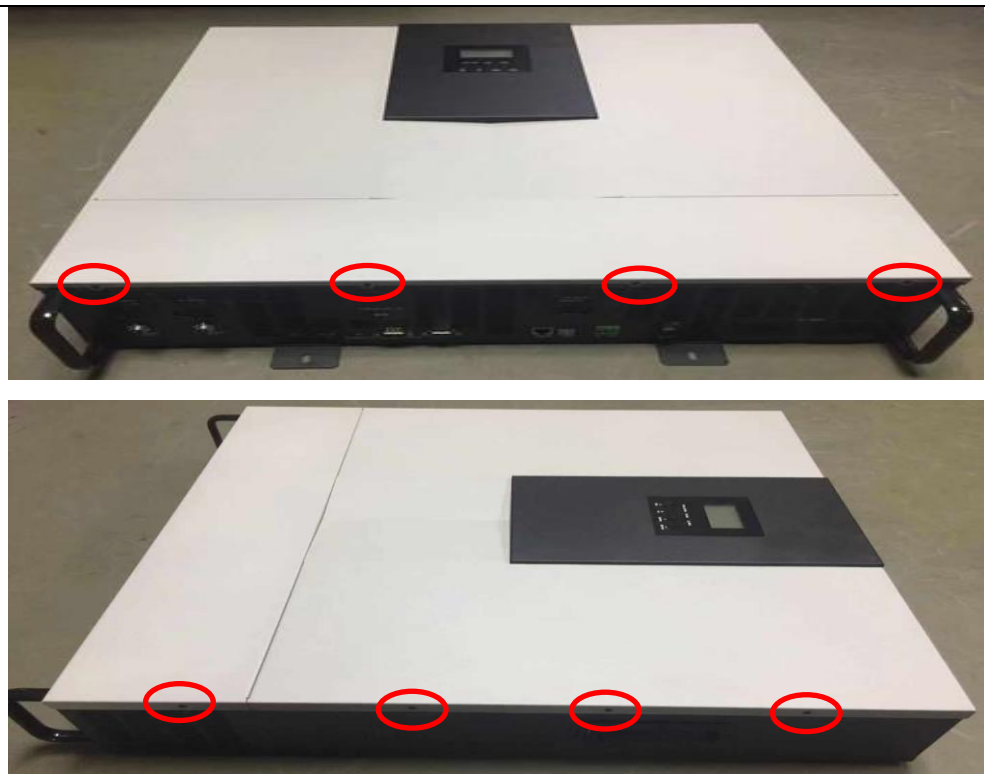
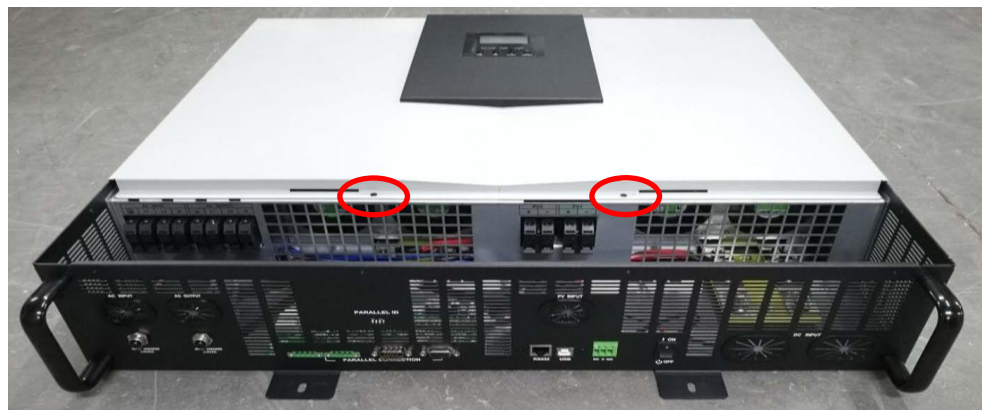
1.1 Open the case

Remove screws on the top cover
